PRESERVATION ASSESSMENT OF MOUNT CALVARY, MOUNT OLIVE, FISHER'S AND POTTER'S CEMETERIES, CITY OF PORTSMOUTH, VIRGINIA

Chicora Research Contribution 533

Prepared By:
Michael Trinkley, Ph.D.
and
Debi Hacker

November 1, 2010

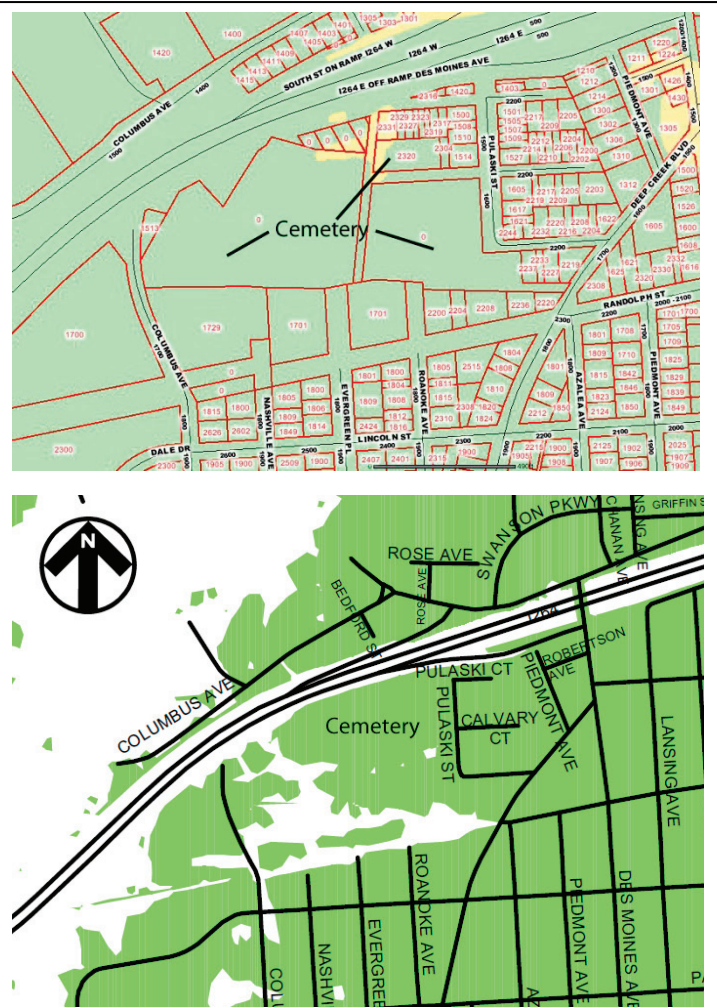
Figure 3. Potential severe flooding of the cemetery complex. The top map shows the 500 year flood in beige against the green background. The bottom map shows flooding resulting from a Category 3 hurricane in green.

A small portion of the north edge of Mount Olive Cemetery is situated in the 500 year flood zone, as is the western third of Fisher's Cemetery, and perhaps a small portion of the northwestern edge of Mount Calvary Cemetery. Additional flooding will be found on the lots to the north, as well as on the north side of I-264.

Of potentially greater consequence is the flooding induced by a hurricane storm surge. A Category 2 hurricane would result in flooding virtually identical to the anticipated 500 year flood. A Category 3 hurricane, however, would result in only small areas of the cemetery complex being untouched – most of the cemetery would be inundated. This would likely cause extensive damage to both graves and the vegetation.

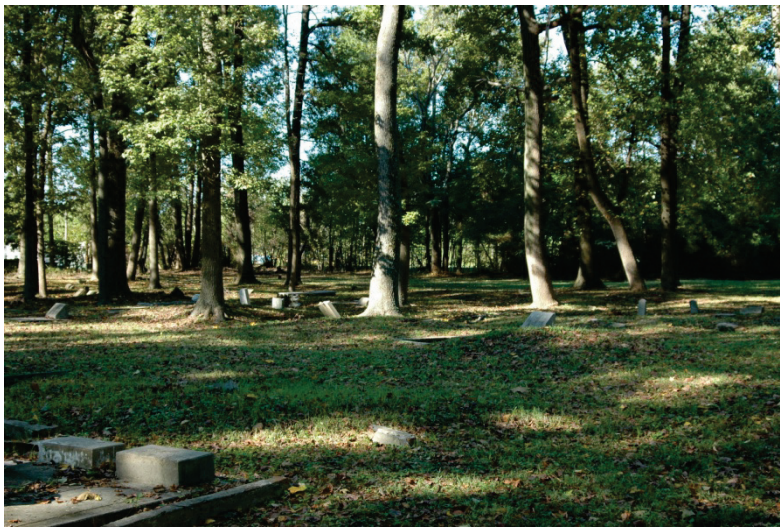
Figure 6. View of Mount Olive showing more abundant vegetation.

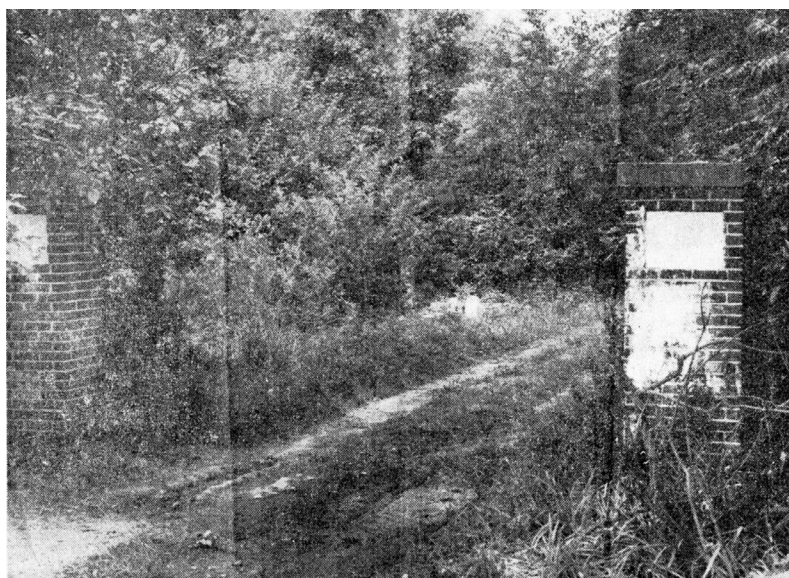
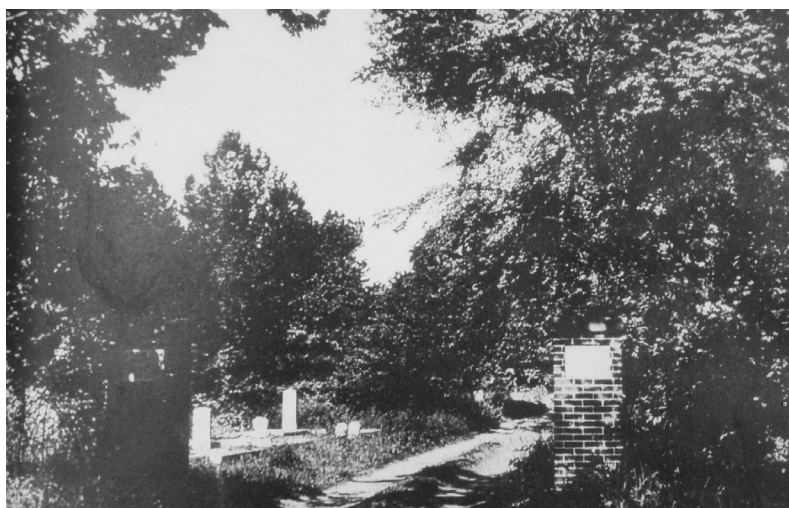
Figure 17. Entrance to Mount Calvary in 1974 and about 1980, when the property was owned by the Wimbrough family. There is some improvement, but even in the 1980s much of the cemetery remained a jungle (1974 is a *Ledger-Star* photo by Mike Williams; ca. 1980 is from the Ester Murdaugh Wilson Memorial Room at the Portsmouth Public Library).

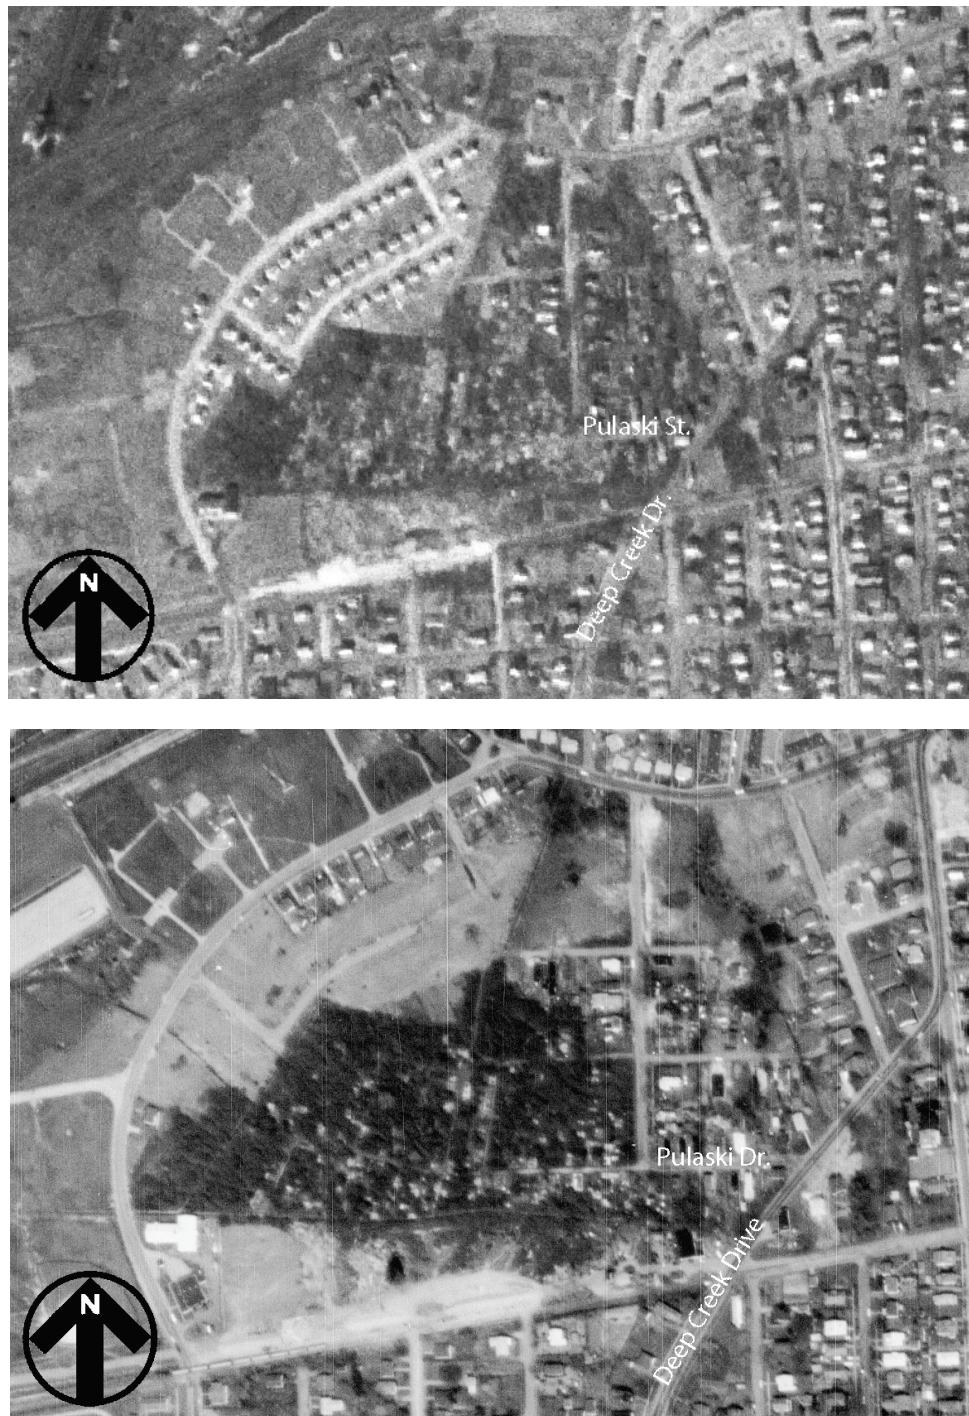
Figure 18. Changes during mid-century. The top aerial is from February 1951. The bottom is from March 1963. These photos show the increase in cemetery vegetation over 13 years, as well as changes in the surrounding neighborhood. Even as late as 1963, however, drainages can be seen north of the cemetery.

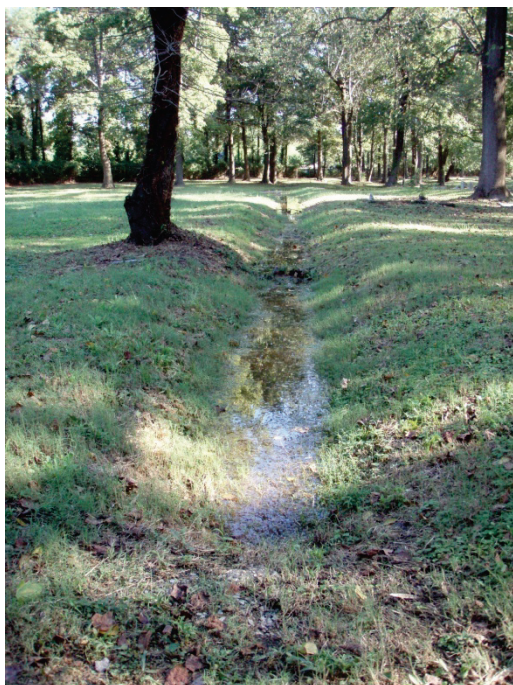
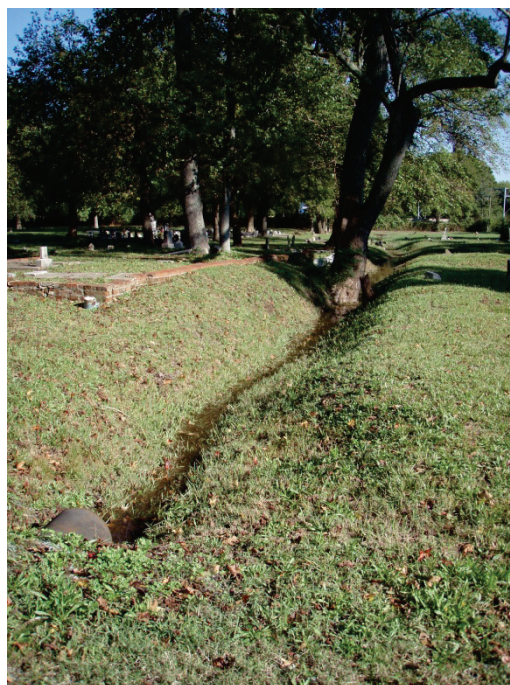
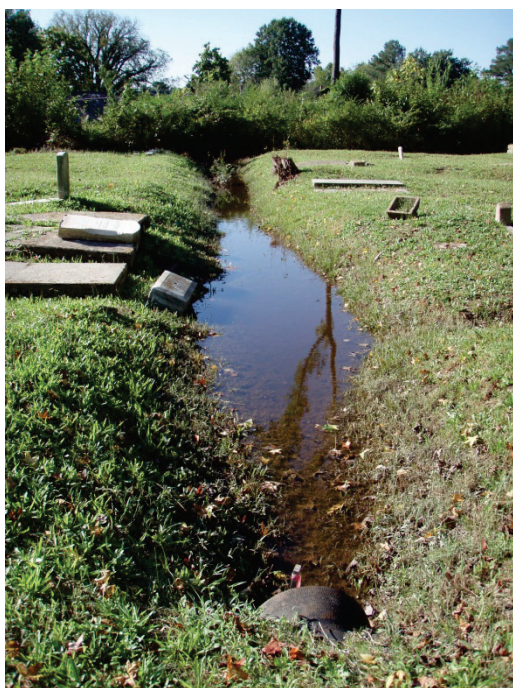
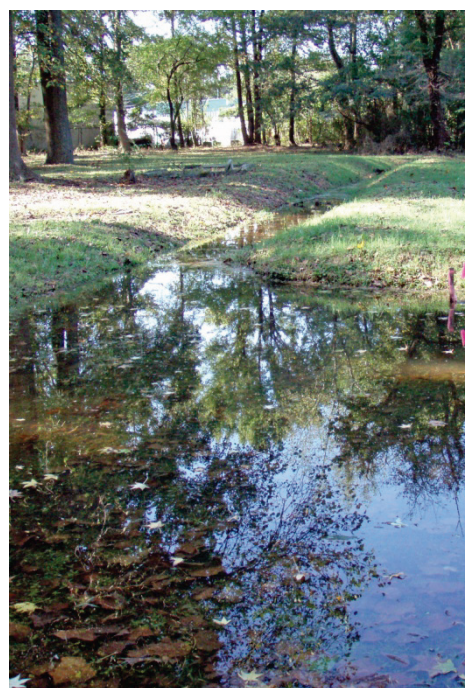
Figure 23. Water drainage in the cemetery after several days without rain. Upper left, north-south ditch near the west end of Mount Olive looking north. Upper right, north-south ditch between Mount Calvary and Mount Olive looking north. Lower left, north-south drain between Mount Calvary and Mount Olive looking south. Lower right, ditch and ponded area at the northwest corner of Mount Olive, looking southwest.

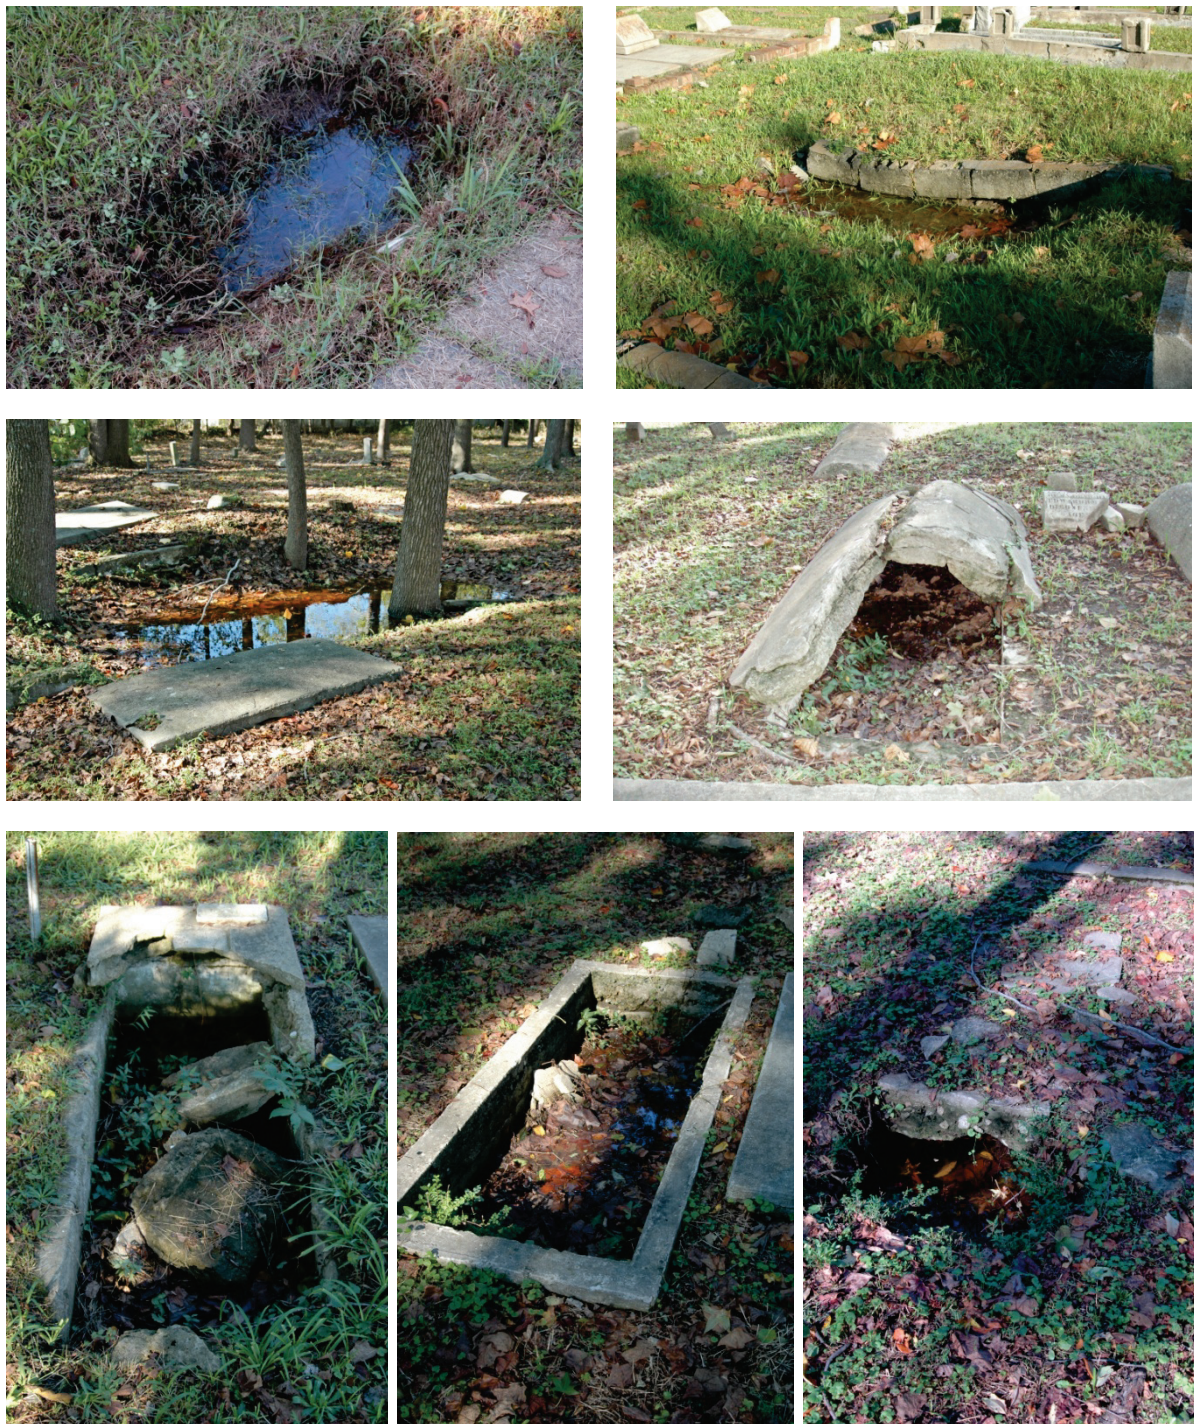
Figure 24. Examples of vaults, sunken graves, and other features filled with standing water on a regular basis.

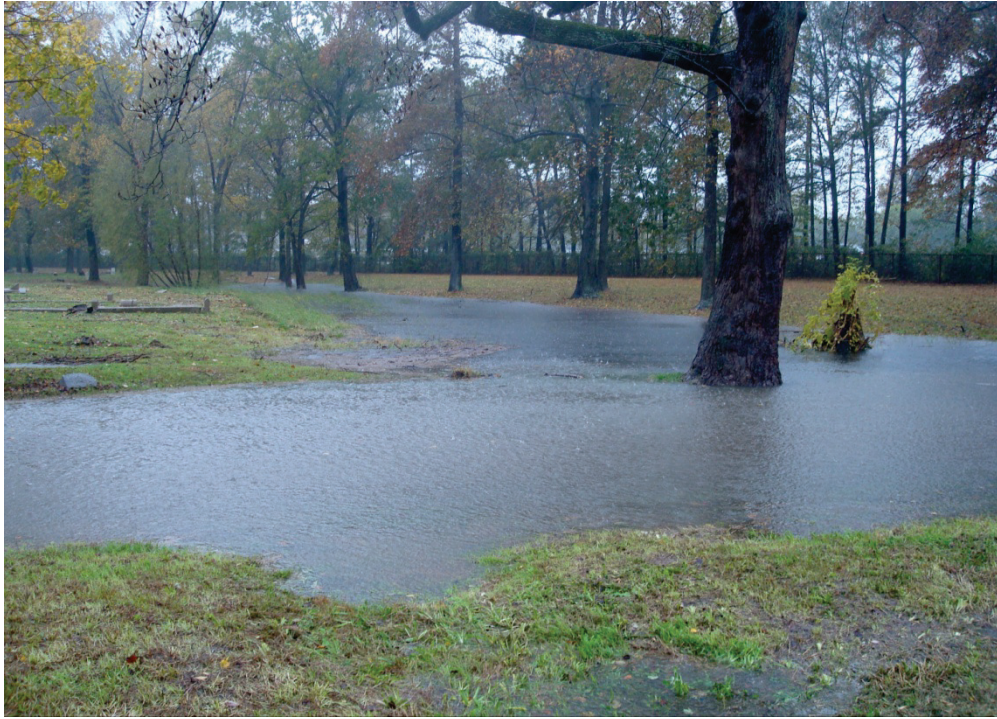
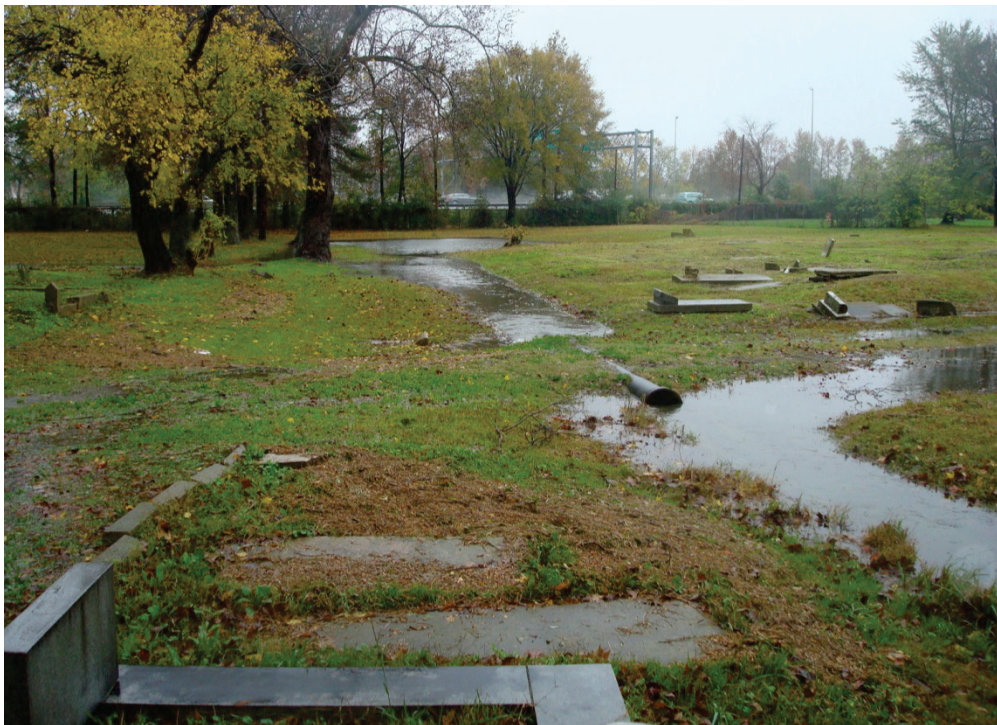
Figure 25. Drainage problems in the cemetery complex during heavy rainfall events. Photos courtesy Christina Carlton.

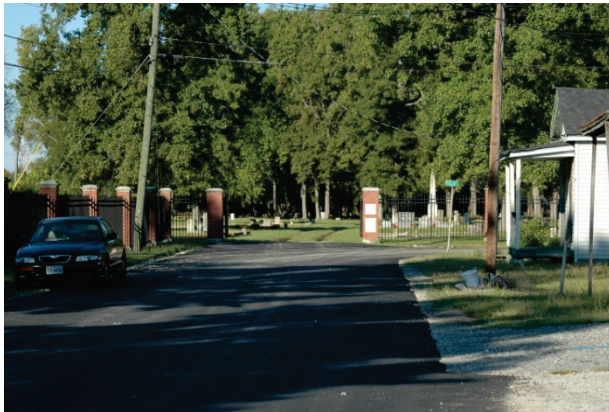
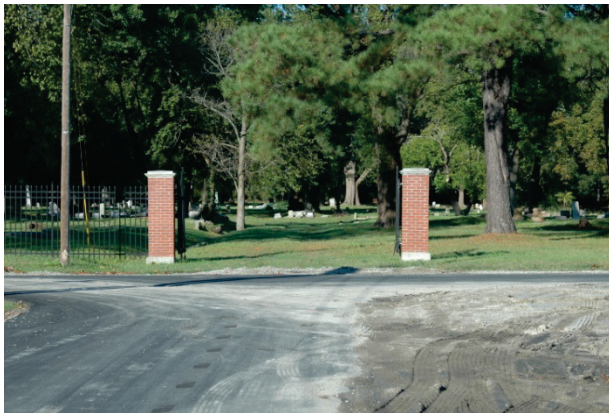
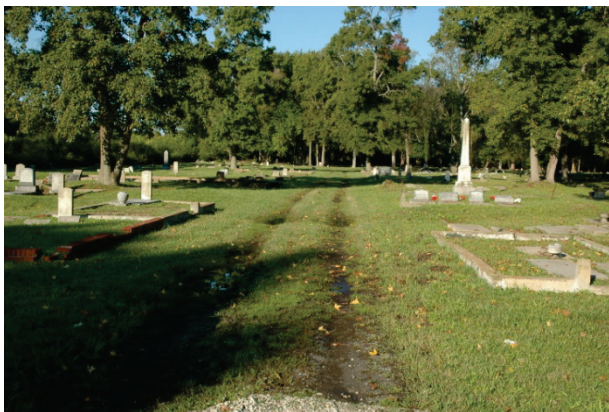
Figure 26. Entrances to the cemetery complex. Upper photo shows the Maple Drive entrance at the end of Pulaski Street. The middle photo shows the Elm Drive entrance at the end of Calvary Street. The bottom photo shows the wet conditions and potholes in Maple Drive at the time of the assessment.

We recommend that the roadways originally identified as Maple, Elm, and Willow be graveled and identified as one-way roads. This would allow visitors to drive into the cemetery

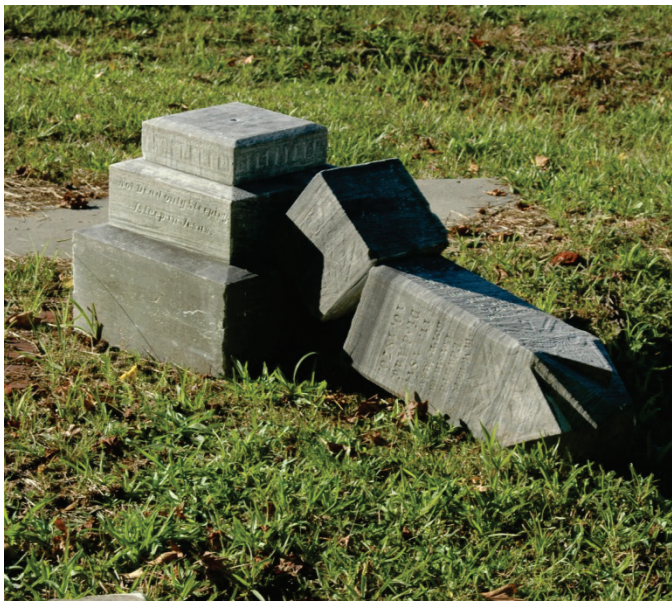
Figure 28. This stone was likely vandalized (the base is relatively level and there are no trees or stumps nearby).

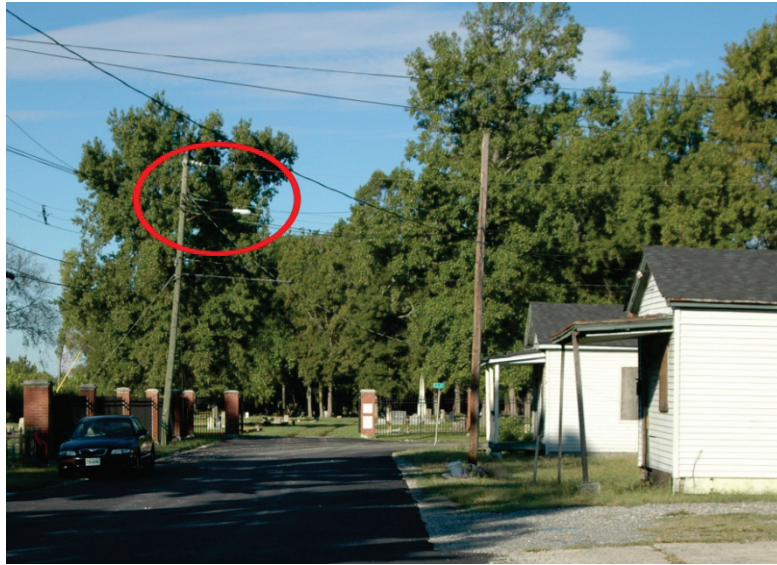
Figure 29. Street lamp at the Maple Drive entrance to Mount Calvary on Pulaski Street.

steel brackets with cobra head luminaires mounted on existing utility poles. A typical example is found immediately before the Maple Drive entrance to the cemetery on Pulaski Street (Figure 29). There are no lights within the cemetery.

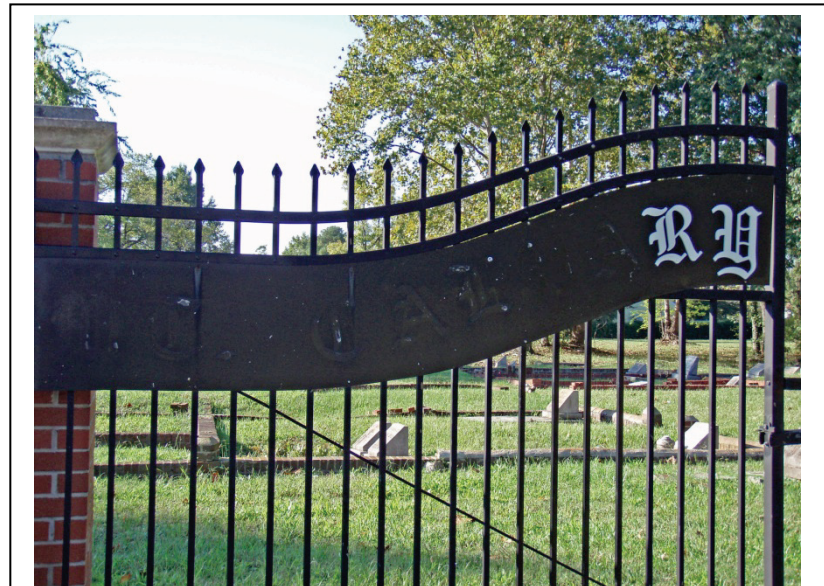
Figure 30. Entrance gate to Mount Calvary showing the loss of letters that require replacement.

In addition, the signage on the fence has been vandalized and is partially missing. This should be immediately replaced by Parks, Recreation and Leisure Services.

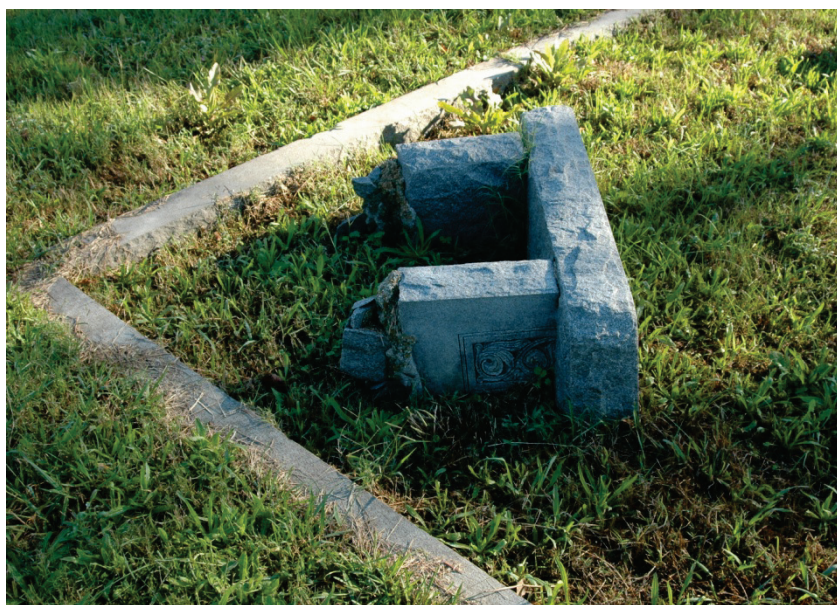
Figure 31. This monumental bench lacked an appropriate foundation, evidencing improper construction.

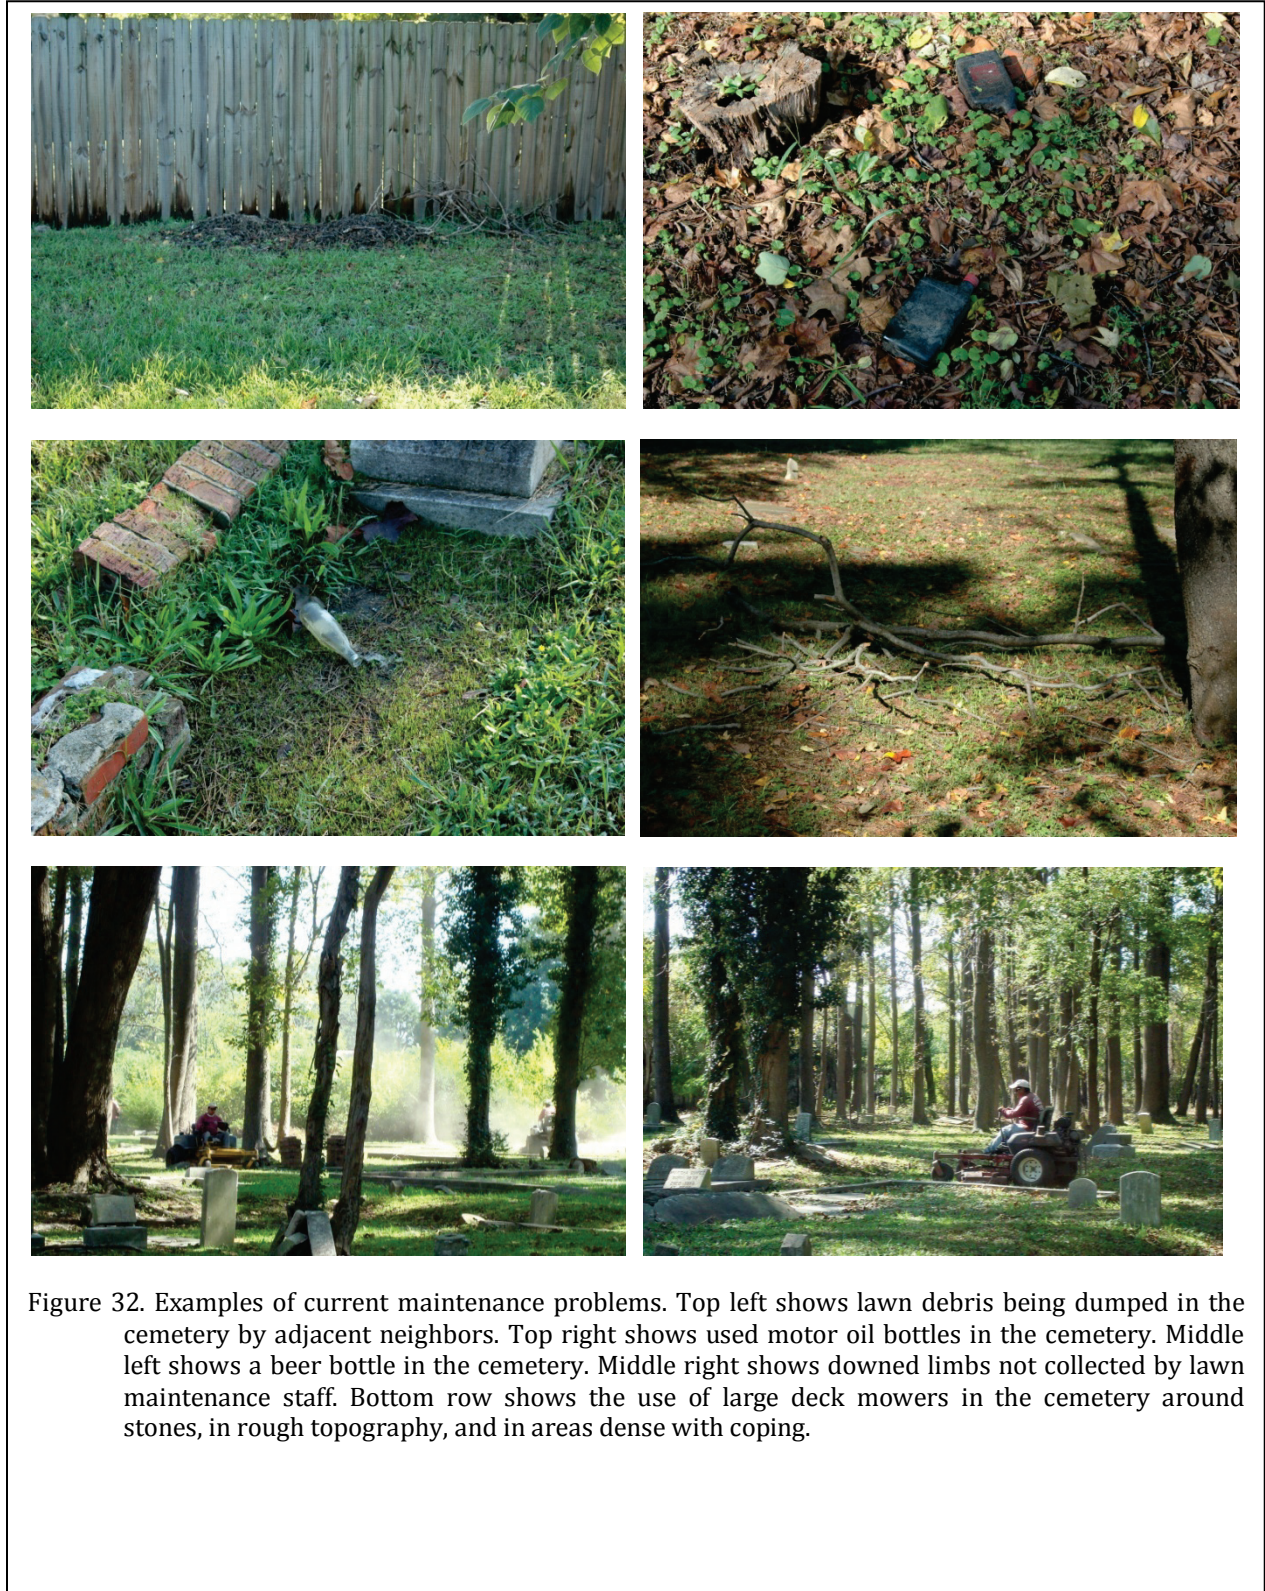
Figure 32. Examples of current maintenance problems. Top left shows lawn debris being dumped in the cemetery by adjacent neighbors. Top right shows used motor oil bottles in the cemetery. Middle left shows a beer bottle in the cemetery. Middle right shows downed limbs not collected by lawn maintenance staff. Bottom row shows the use of large deck mowers in the cemetery around stones, in rough topography, and in areas dense with coping.

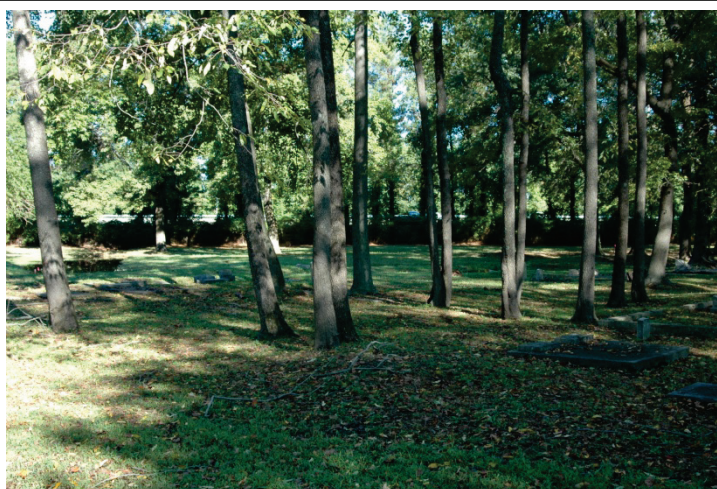
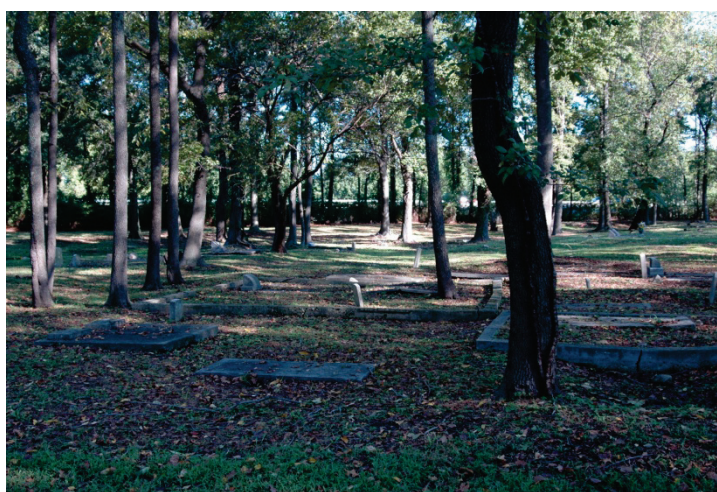
Figure 33. Dense trees in Mount Olive require thinning with the removal of all trees under 9-inch dbh.

There are a large number of trees that have grown up in the cemetery over the past 50 years that require removal, both for the benefit of monument preservation, the landscape, and also to encourage drying of soils. We recommend the

removal of between 30 and 50 trees under 10-inches diameter breast height (dbh) or that are damaged.

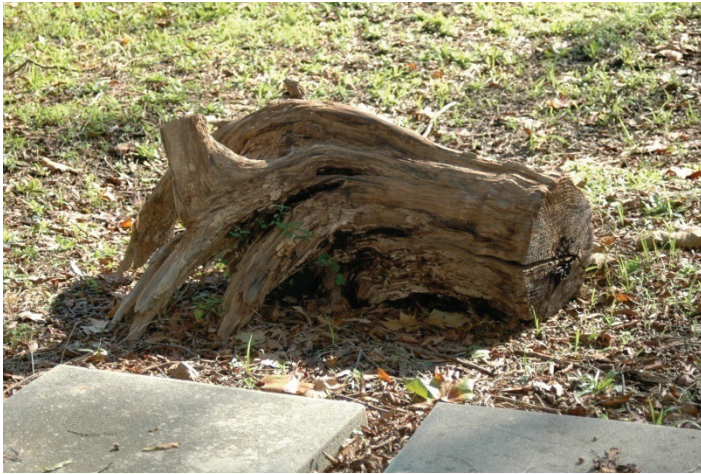
Figure 34. Stump left in the cemetery. All stumps and downed wood should be removed from the cemetery or chipped as quickly as possible.

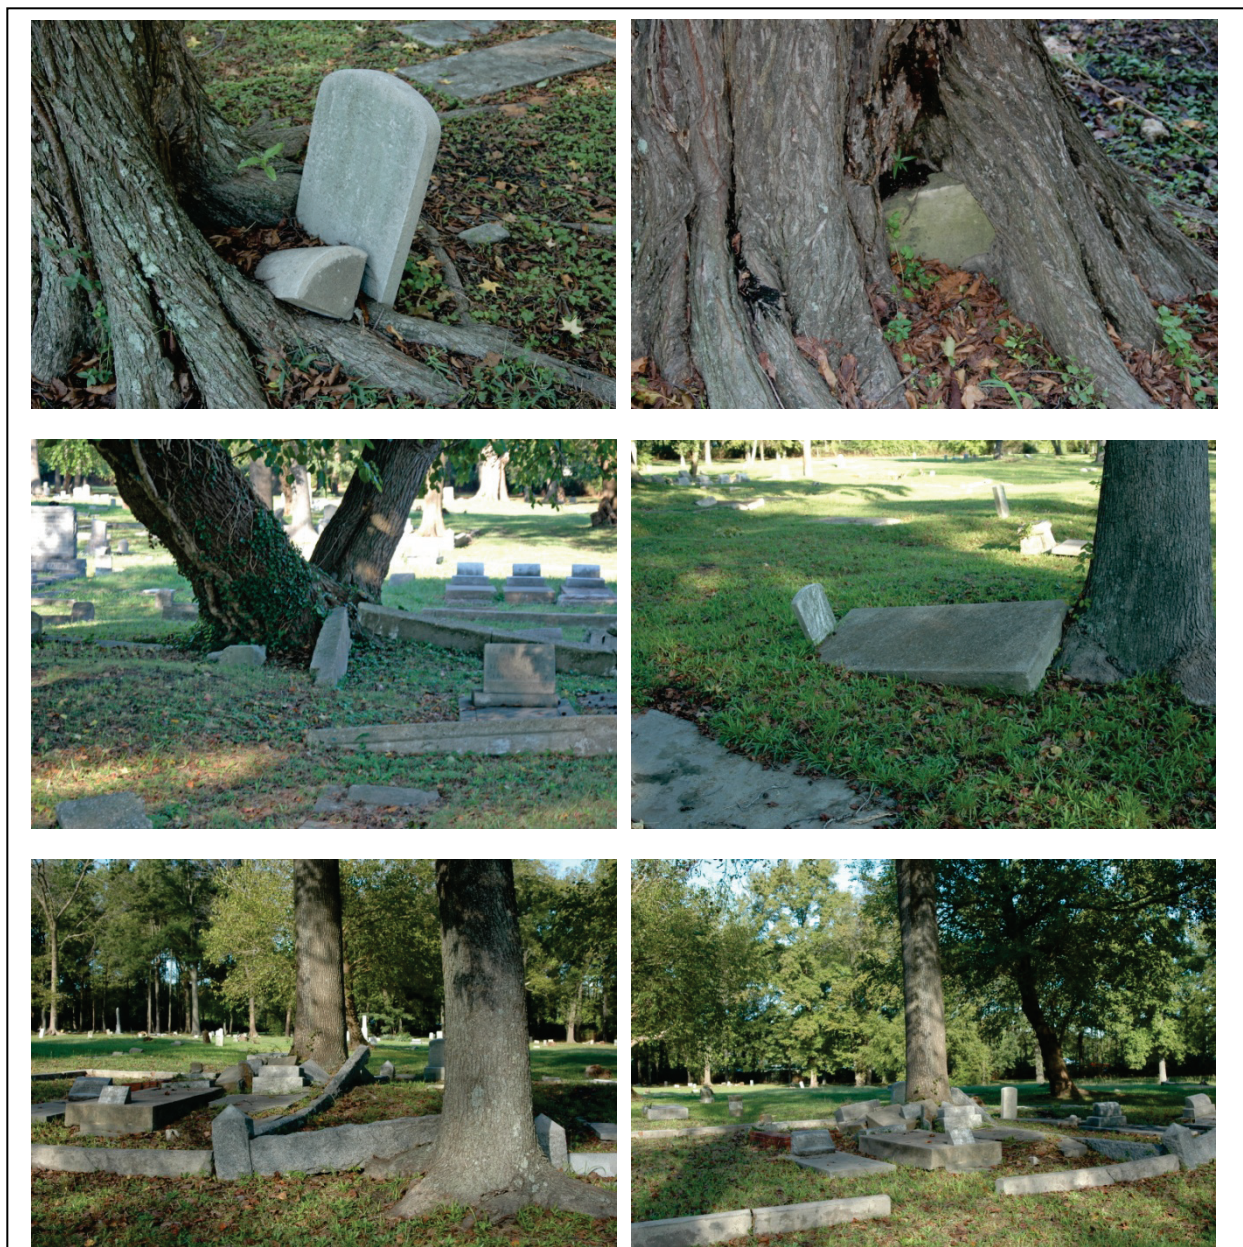
Figure 35. Examples of plots or stones damaged by tree growth. The top left photo shows a large tree with roots beginning to encompass a tablet. Here it may be possible to remove the stone without damage to the tree. The top right photo shows a stone completely grown into a tree. The stone cannot be recovered without killing the tree – which we do not recommend. Middle row left photo shows coping displaced by a large tree. We recommend relocating the coping to avoid the tree. Middle row right photo shows a large tree growing into a vault. It may be possible to relocate the vault cover and tablet. Lower row left and right photos show extensive damage to coping and stones by a large tree. Here it may be possible to relocate coping and stones to avoid the tree. In most cases the tree, if mature and healthy, should be retained.

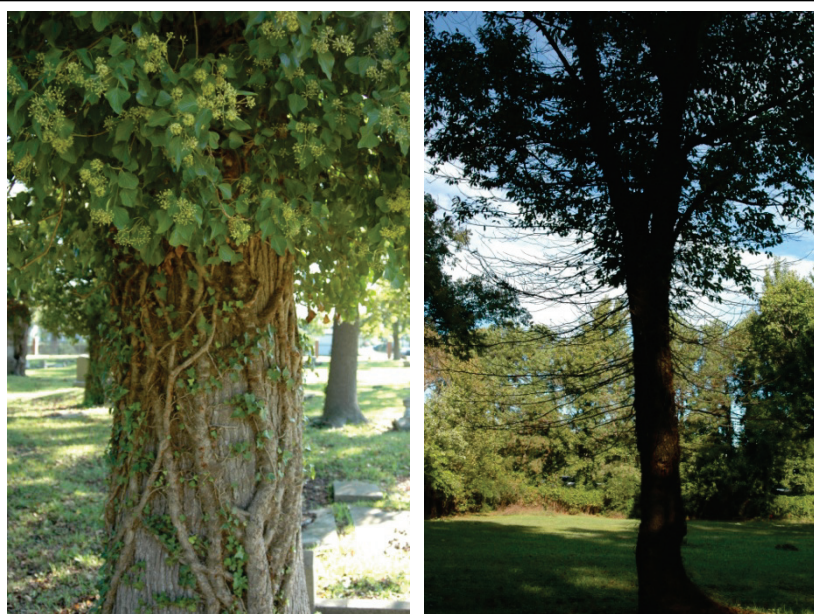
Figure 36. Examples of invasive plants in the cemetery. On the left is flowering English ivy choking a tree. On the right is poison ivy after shedding its leaves. Both should be cut and the stems painted with undiluted Roundup Promax®.

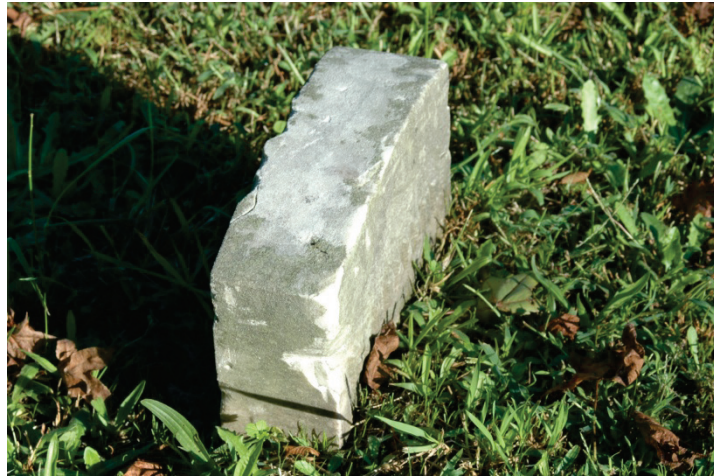
Figure 37. Damage to stones in the cemetery caused by mowers. Top photo shows numerous direct hits causing chipping. Bottom photo shows not only a direct hit on the left, but also a long scrape across the stone. These are the result of using equipment that is too large for cemetery, coupled with inattentive and unsupervised workers.

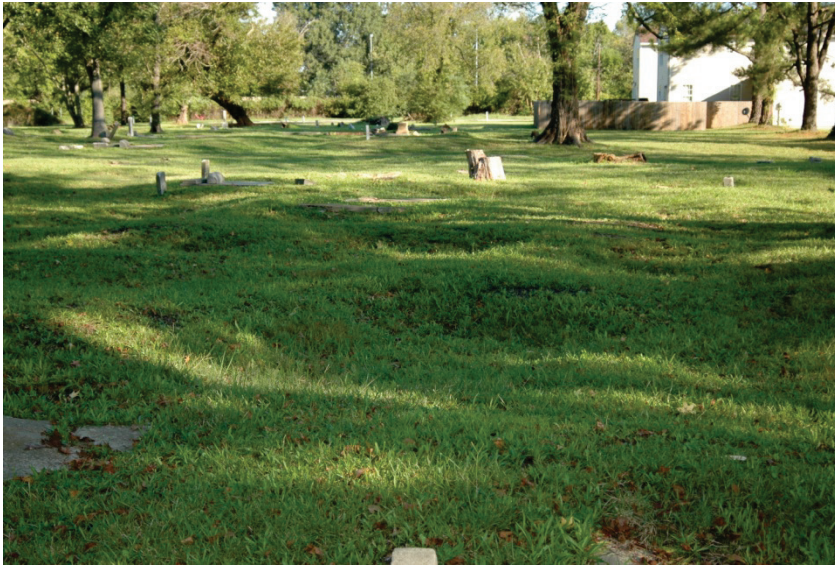
Figure 38. Undulating topography is a clear indication of sunken graves. All of these require mapping prior to being infilled with clean sand.

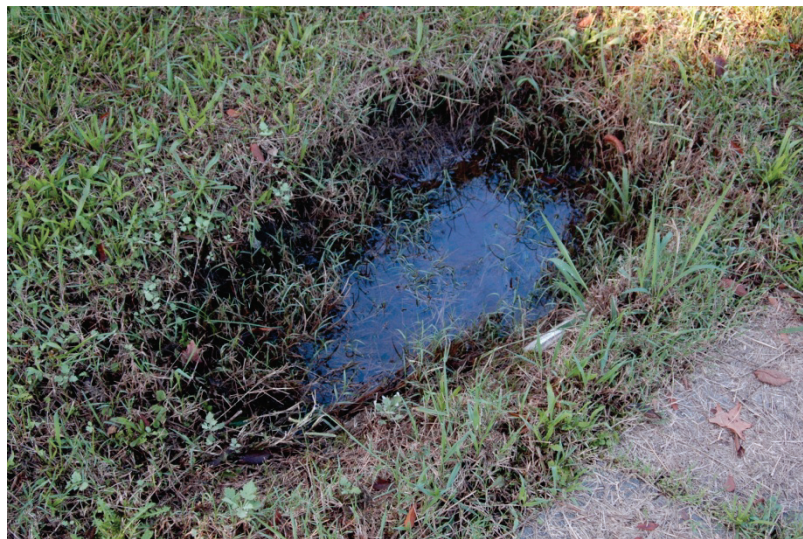
Figure 39. Sunken graves can be infilled with sand once they have been mapped.

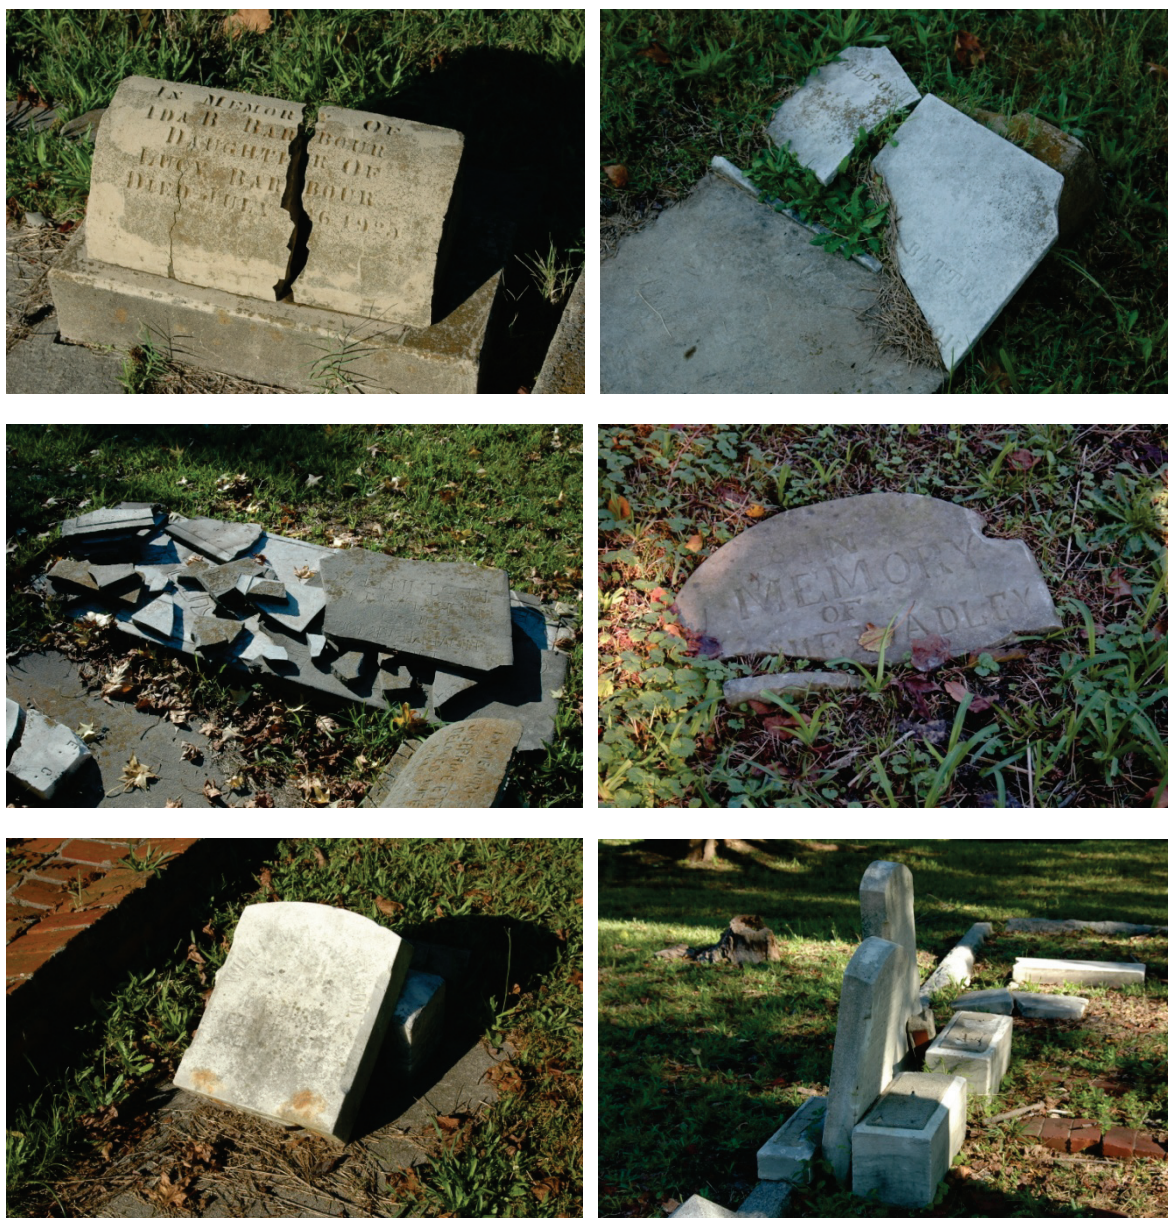
Figure 40. Types of stone damage at the cemetery complex. Upper left is a cast Portland cement stone that has broken and is cracked. This stone may be treated using a simple epoxy repair. Upper right is a thin marble headstone that has broken. This is an example of a stone that will require a blind pin repair using fiberglass rods. Middle left is a Portland cement ledger that has shattered. Careful inspection reveals one was laid over a pre-existing ledger (which has also shattered). This will be a very complex repair, requiring that each fragment be pieced back together. Middle right is a broken marble stone, also a candidate for a blind pin repair. Lower left is a stone with two ferrous pins. These pins must be removed and replaced with stainless steel; the stone can then be reset. Lower right shows two stones with ferrous pins. They require the replacement of the ferrous pins, as well as the removal of the thick cement coating that was used.

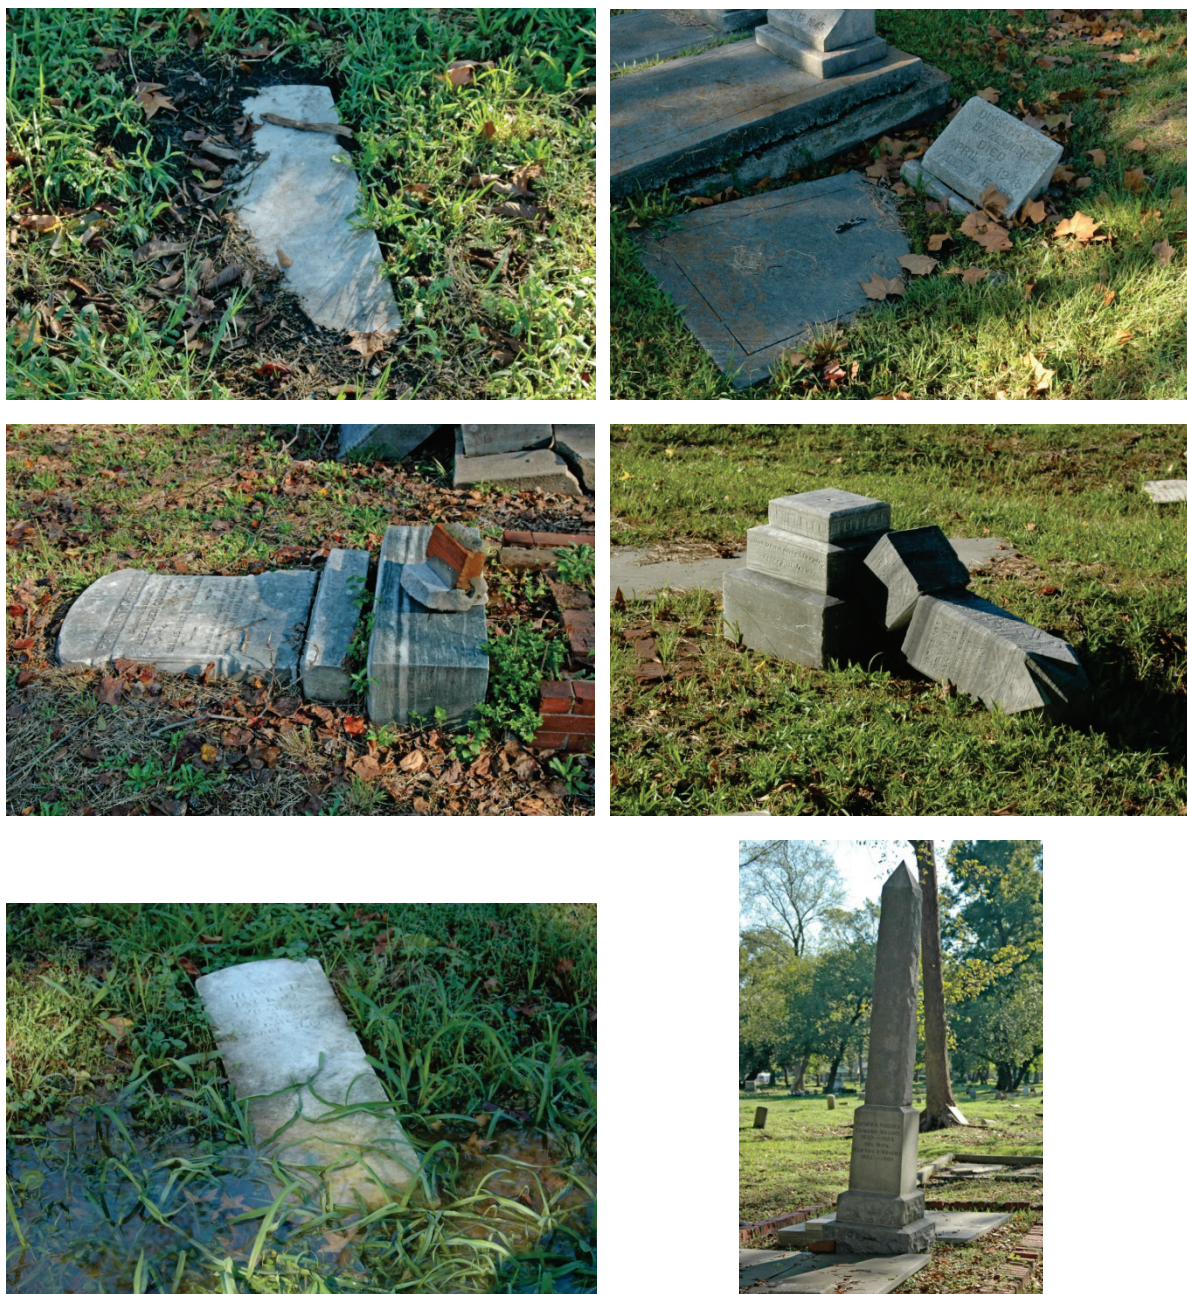
Figure 41. Damaged stones in the cemetery complex. Upper left, fallen stone that has become partially buried. This stone requires resetting. Upper right, collapsing ledger. This ledger requires releveled with the slant top marker at the head being reset. Middle left, probable vandalized stone. Resetting may require replacement of ferrous pins. Middle right shows a toppled pedestal tomb that should be reset. Stainless steel pins should be inserted to prevent future vandalism. Lower left, displaced military stone. Although the grave location has been lost, the stone should be reset as a memorial with notes made that it may no longer identify the grave location. Lower right, example of a severely leaning obelisk that requires immediate resetting because of the hazard to the public.

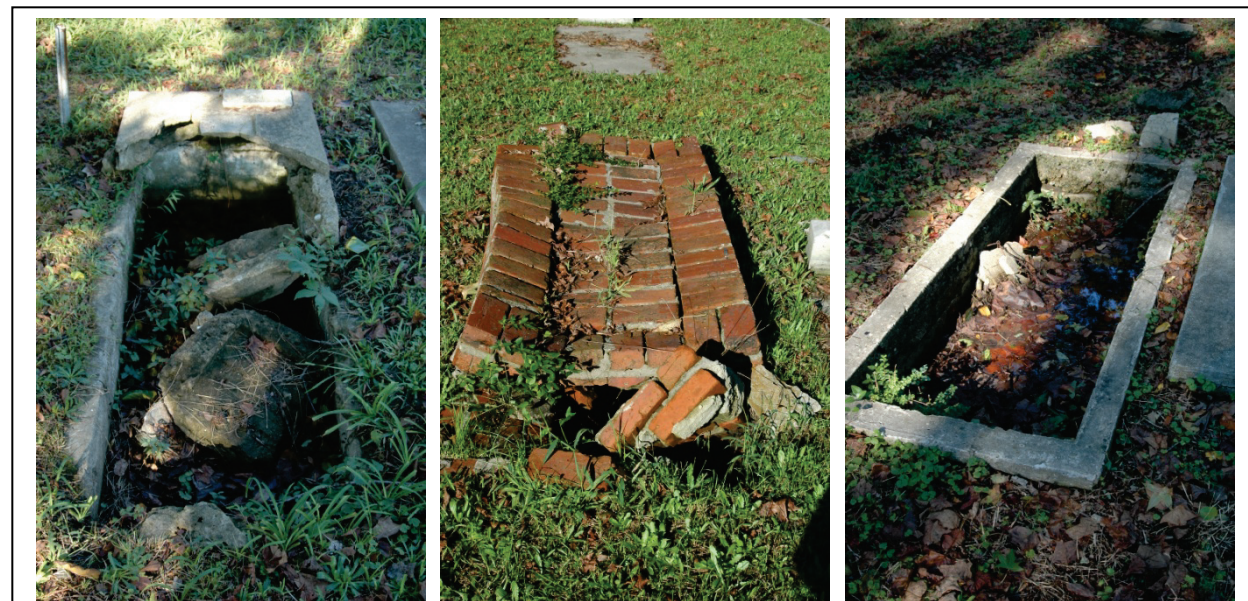
Figure 42. Examples of damaged (or lost) vault tops that should be replaced with new cast concrete slabs.
